**Flood Control Project Maintenance
Levee Inspections**

Maintenance Issue Types Only, Levee Inspection Report By Mile - Spring 2019

Reclamation District No. 2095 Paradise Cut

Waterway	Bank	Unit Miles	Inspection Start/End	Inspector
Unit No. 01 Paradise Cut	Left	1.45	05/01/2019 05/01/2019	Alberto De Leon

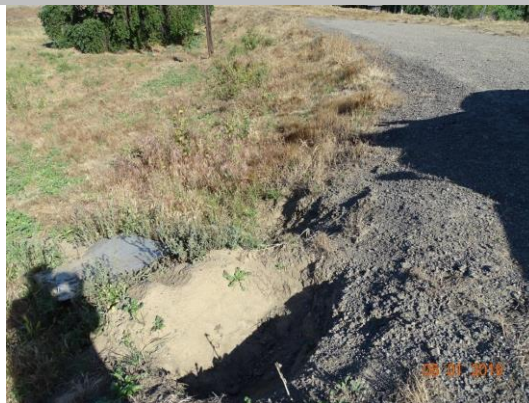
Photo 1 of 1 : SP_2019_RD2095_322_5_20190514_00015.jpg

LM Start	0.10	Rating **	M	Issue No.	5
LM End	0.10	Issue Type +	Ma	Location *	LS
Category	Earthen Levee			GPS Latitude/Longitude	
				Start	End
Item	Erosion / Bank Caving			37.770311 °	37.770311 °
				-121.325884 °	-121.325884 °
DWR ID	DWR_RD2095_01_s_2019_5				
Comment Code					
E2 : Schedule repair of erosion site prior to the next inspection.					
Inspector Comment					
Repair erosion caused by motorcycle traffic.

View of landside slope with an erosion area caused by motorcycle riders creating ruts and jumps. (Spring 2019)

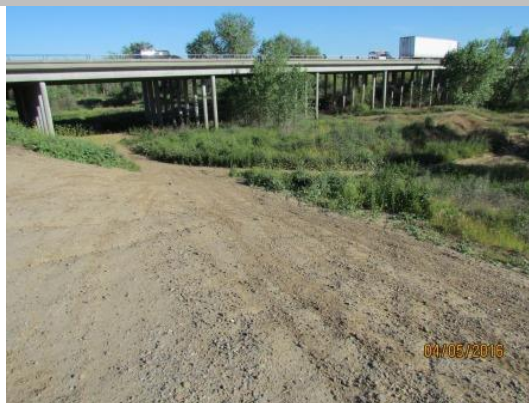
Photo 1 of 1 : SP_2019_RD2095_322_10_20190313_00001.jpg

LM Start	0.15	Rating **	A/W	Issue No.	10
LM End	0.15	Issue Type +	Ma	Location *	WS
Category	Earthen Levee			GPS Latitude/Longitude	
				Start	End
Item	Slope Stability			37.769997 °	37.769997 °
				-121.325055 °	-121.325055 °
DWR ID	DWR_RD2095_01_f_2015_10				
Comment Code					
S3 : Repair the levee slope damaged by vehicle traffic and prevent access where possible.					
Inspector Comment					
LMA is actively controlling access. The slope appears to be stable and should be monitored for possible erosion.

View of the vehicle tracks on the waterside levee slope.

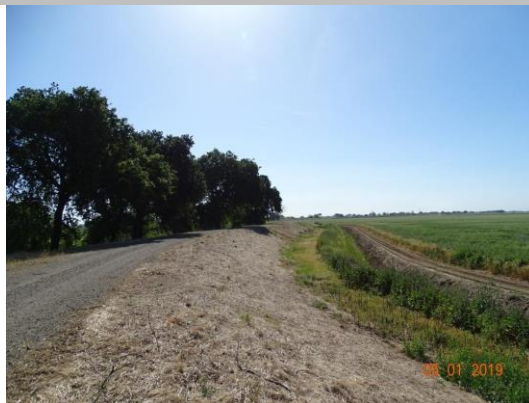
Photo 1 of 1 : SP_2019_RD2095_323_9_20190514_00020.jpg

LM Start	0.00	Rating **	A	Issue No.	9
LM End	3.41	Issue Type +	Ma	Location *	LS
Category	Earthen Levee			GPS Latitude/Longitude	
				Start	End
Item	Vegetation			37.759246 °	37.717755 °
				-121.308296 °	-121.304852 °
DWR ID	DWR_RD2095_02_s_2019_9				
Comment Code					
V1 : Control annual grass and weeds on the levee slopes and easements.					
Inspector Comment					
Annual vegetation is well maintained.

Typical view of vegetation on landside slope. (Spring 2019)

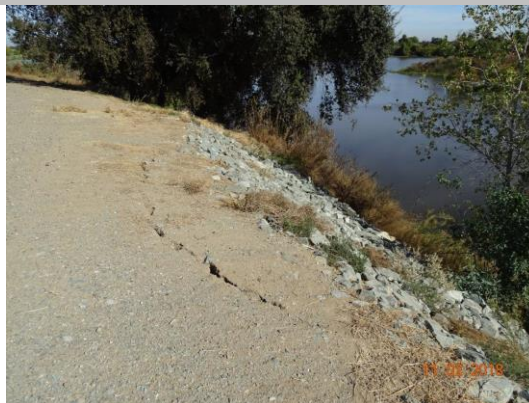
Photo 1 of 1 : SP_2019_RD2095_323_10_20190313_00006.jpg

LM Start	1.33	Rating **	M	Issue No.	10
LM End	1.33	Issue Type +	Ma	Location *	WS
Category	Earthen Levee			GPS Latitude/Longitude	
				Start	End
Item	Cracking			37.744904 °	37.744904 °
				-121.297679 °	-121.297679 °
DWR ID	DWR_RD2095_02_f_2018_10				
Comment Code					
CR1 : Monitor and have inspected by geotechnical engineer.					
Inspector Comment					
There is a large crack on the waterside shoulder at a previous erosion repair site. Recommend getting a geotechnical engineer to evaluate the crack.

View of cracking on waterside shoulder. Fall 2018.

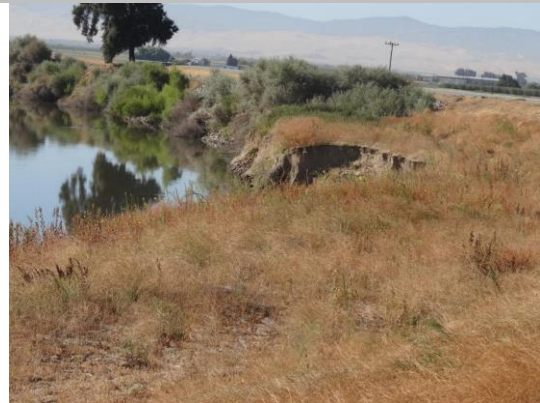
Photo 1 of 4 : SP_2019_RD2095_323_1_20190313_00001.jpg

Comment Code					
Inspector Comment					
10/04/2017: The erosion has further expanded toward the levee toe. The berm width has shortened to approximately 14 feet. The erosion also has further lengthened upstream. Vegetation has grown denser at the site.					
07/20/2016: The erosion extended toward the levee toe. The berm width was reduced by approximately five (5) feet.					
08/04/2015: No significant change observed.					
07/02/2014: No significant change observed.					
08/28/2013: No significant change observed.					
09/13/2012: The site has been visited by land survey. The vegetation on the site shows the erosion has not developed significantly from the last survey.					
The site was not visited by boat survey due to the limitation of navigable waterway.					
08/23/2011: No significant change observed.					
9/22/2010: No significant change observed. There is moderate vegetation growth on the berm. Despite the erosion occurring on the berm, corrective action should be taken before the issue becomes severe.

9/29/2009: Site is immediately downstream of a section of existing rip rap; there is a 20-foot berm remaining; berm will continue to erode unless erosion is mitigated; Site# is the same as RM62.6, LM1.87; recommended for annual assessment, per CES Evaluation 2008 Report 2006: Visited 10/20/06 [2017 Site ID:RD2095U02RM60.62]

Looking at the erosion from downstream.

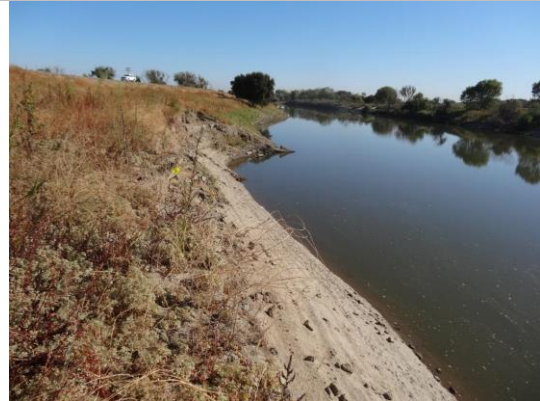
Photo 2 of 4 : SP_2019_RD2095_323_1_20190313_00002.jpg

Comment Code					
Inspector Comment					
10/04/2017: The erosion has further expanded toward the levee toe. The berm width has shortened to approximately 14 feet. The erosion also has further lengthened upstream. Vegetation has grown denser at the site.					
07/20/2016: The erosion extended toward the levee toe. The berm width was reduced by approximately five (5) feet.					
08/04/2015: No significant change observed.					
07/02/2014: No significant change observed.					
08/28/2013: No significant change observed.					
09/13/2012: The site has been visited by land survey. The vegetation on the site shows the erosion has not developed significantly from the last survey.					
The site was not visited by boat survey due to the limitation of navigable waterway.					
08/23/2011: No significant change observed.					
9/22/2010: No significant change observed. There is moderate vegetation growth on the berm. Despite the erosion occurring on the berm, corrective action should be taken before the issue becomes severe.

Looking at the erosion from upstream.

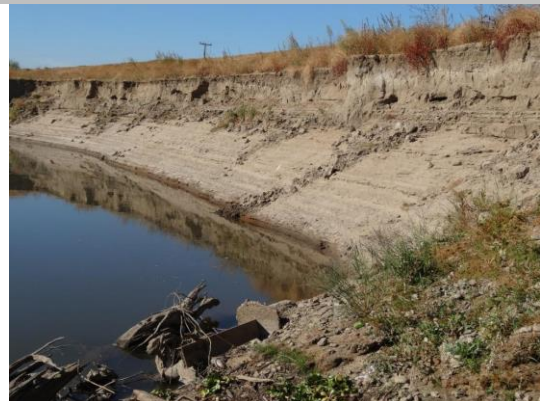
Photo 3 of 4 : SP_2019_RD2095_323_1_20190313_00003.jpg

Close view of the erosion.

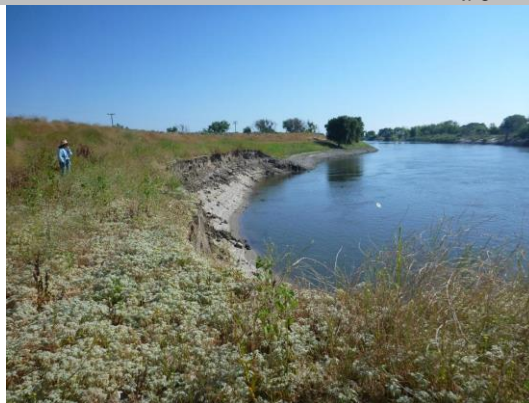
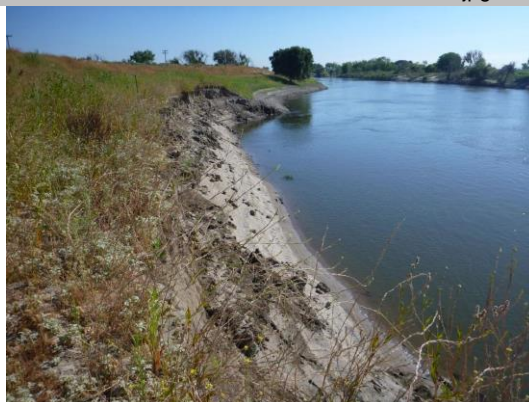
Comment Code					
Inspector Comment					
Levee Evaluation Comments					
Description:Active waterside erosion on San Joaquin River near the end of Wright Road in Tracy, CA. Total length of erosion extends 615. Erosion has extended 15 feet towards levee toe this flood season. Pleasee see attached map and photots. As the high water level receds from the winter storm, we can see more damage to this stie. Erosion is active.					
Site ID No:469					
Site Designation:LMA-296					
Repair Type: Erosion					
Rating:Serious					
Field Date:7/26/2017					
Notes: This is an active erosion site. Zero vegetation within the eroded portion. It may not be quite in the prism now, but lost about 20 ft (horizontally) of bank last year. Saw eddies in the water here also.

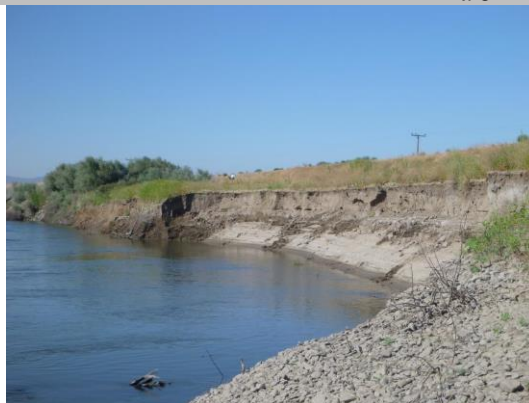
Photo 3 of 3 : LEVAL_SP_2019_469_2353.jpg

Comment Code						
Inspector Comment						
Levee Evaluation Comments						
Description:Active waterside erosion on San Joaquin River near the end of Wright Road in Tracy, CA. Total length of erosion extends 615. Erosion has extended 15 feet towards levee toe this flood season. Pleasee see attached map and photots. As the high water level receds from the winter storm, we can see more damage to this stie. Erosion is active.						
Site ID No:469						
Site Designation:LMA-296						
Repair Type: Erosion						
Rating:Serious						
Field Date:7/26/2017						
Notes: This is an active erosion site. Zero vegetation within the eroded portion. It may not be quite in the prism now, but lost about 20 ft (horizontally) of bank last year. Saw eddies in the water here also.

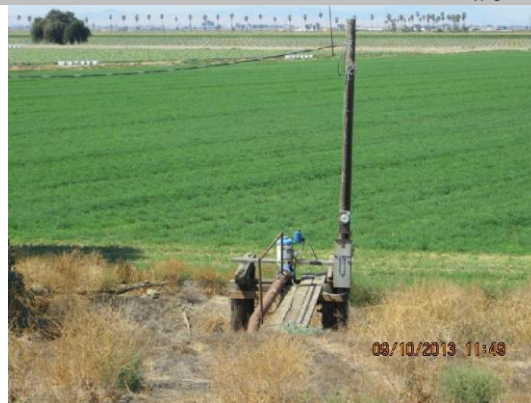
Photo 1 of 2 : UCIP_SP_2019_19871_33778.jpg

LM Start	2.38	Rating **	A/W	Issue No.	945
LM End	2.38	Issue Type +	Ma	Location *	
Category	Supplemental			GPS Latitude/Longitude	
				Start	End
Item	DWR UCIP LMA Responsibility			37.731313 °	37.731313 °
				-121.298298 °	-121.298298 °
DWR ID	21644				
Comment Code					
Inspector Comment					
FS_ID:19871 DS_ID:21644 EP_NO: N/A Repair Type: No Action Needed Crossing Status: Found UCIP Comments: FIELD_STRUCT_DESC: 8-inch steel drainage pipe through the levee, 3 feet below the crown. Pump in drainage ditch on the landside (LS). Vent pipe at the waterside (WS) toe. 1.5-inch galvanized iron electrical conduit through the levee at the same location. Service pole with a switch box and meter on the LS. [Additional Reference(s): DWR Levee Log, 2005. USACE San Joaquin O&M Manual 11, 1968, (HLM 2.41)]. FS Date: 9/10/2013

Pump on metal pier off LS toe.

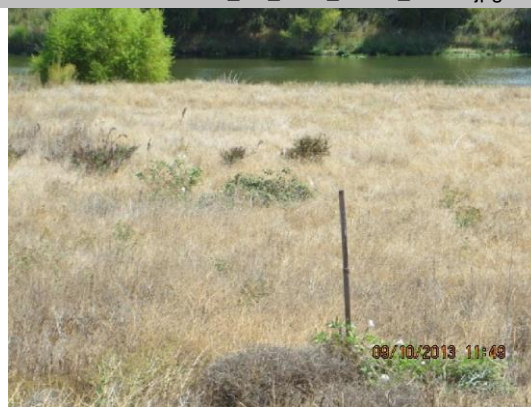
Photo 2 of 2 : UCIP_SP_2019_19871_33777.jpg

Vent standpipe on WS toe.
